MY "FRANZISCA"

Hull Inspection Report

Reference: 2271021

MATTER: M.Y. "FRANZISKA" hull inspection below waterline

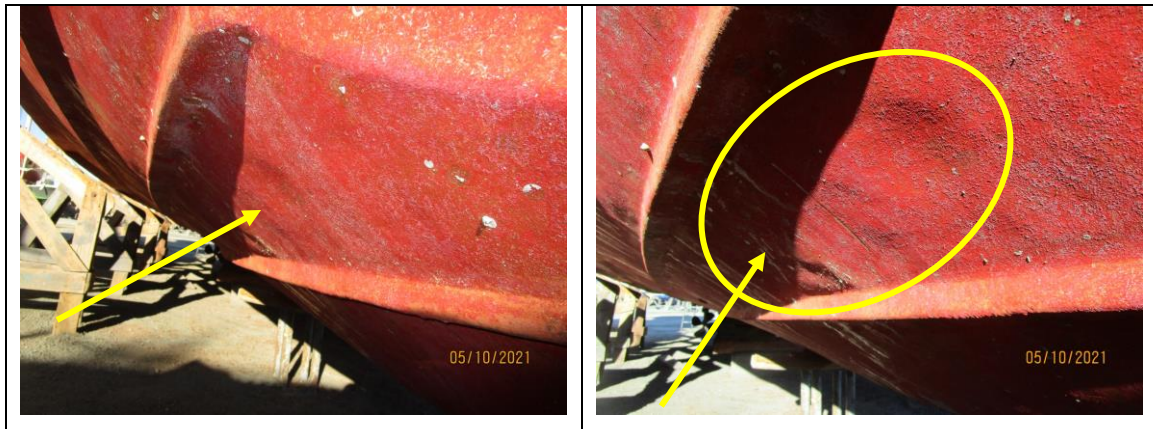
- Bow side of the boat was repaired before (starboard side). The hull in that area was not flat.

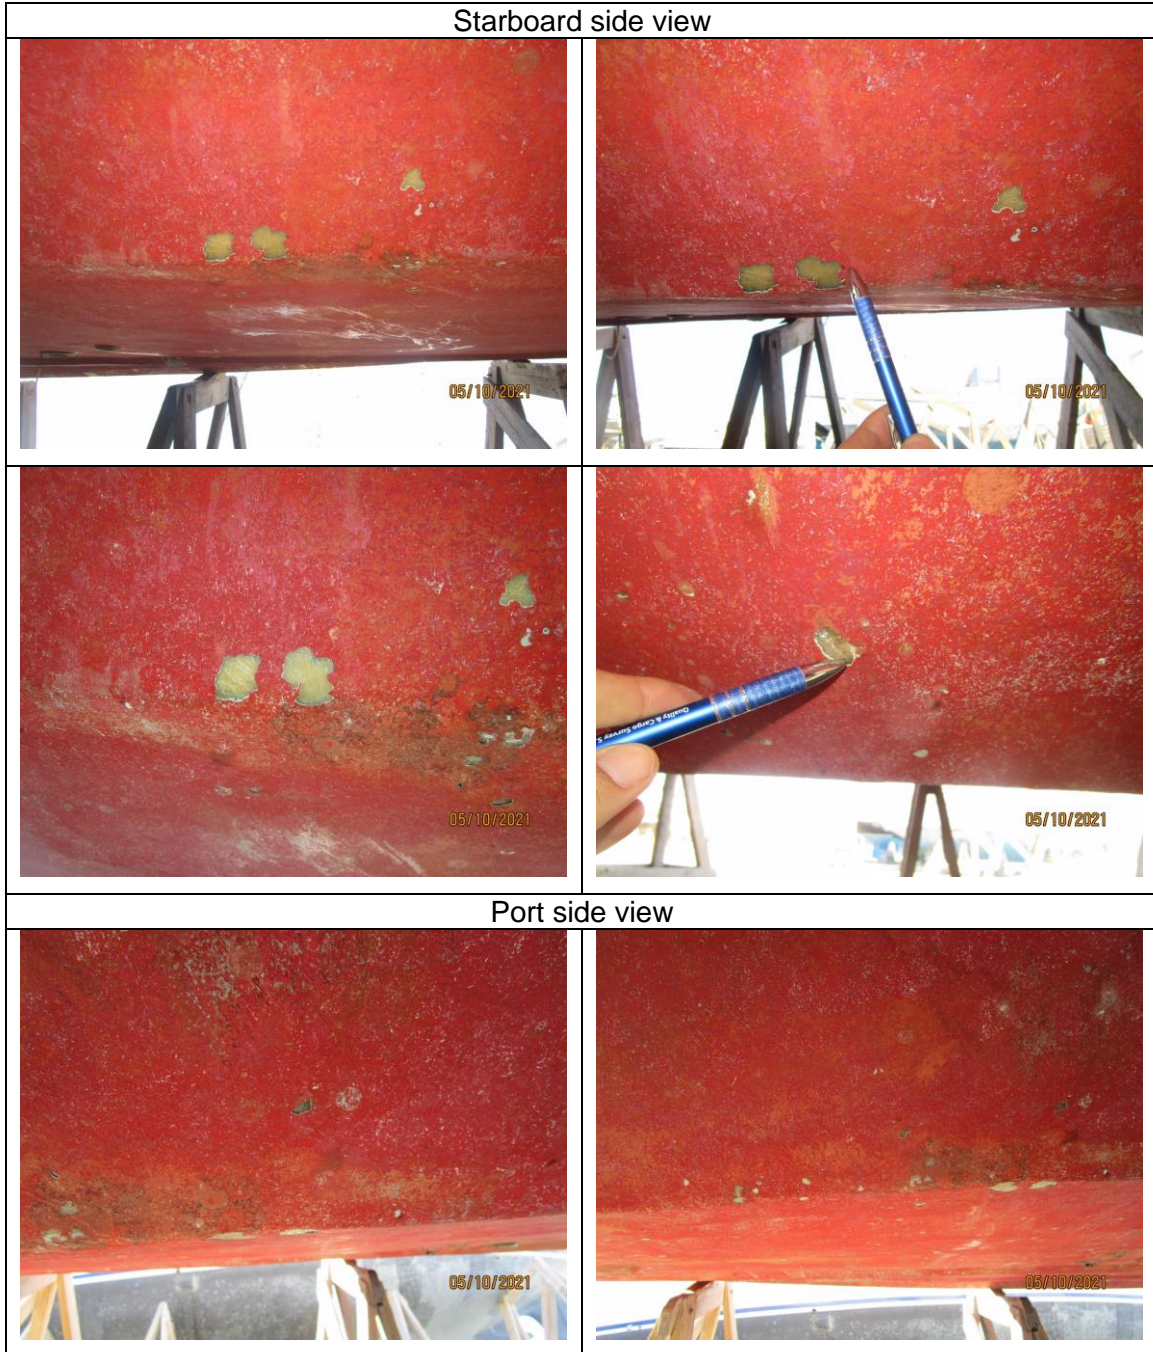
- There was an area in the keel at the centre of the boat where it was found some small spots which the topcoat was missing. Fibre and resin were exposed.

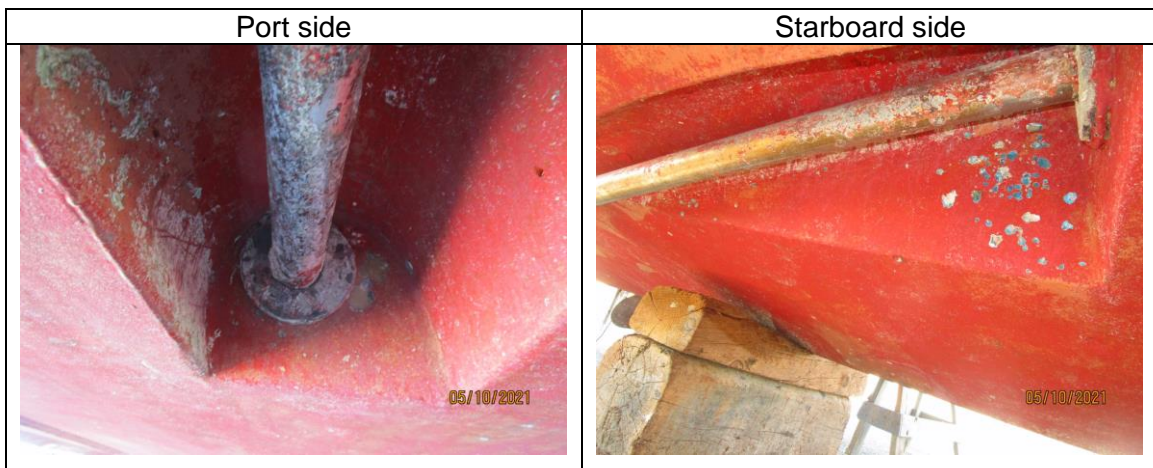
- Next to the shaft stern tube (in both sides), there is some pitting in the antifouling paint.

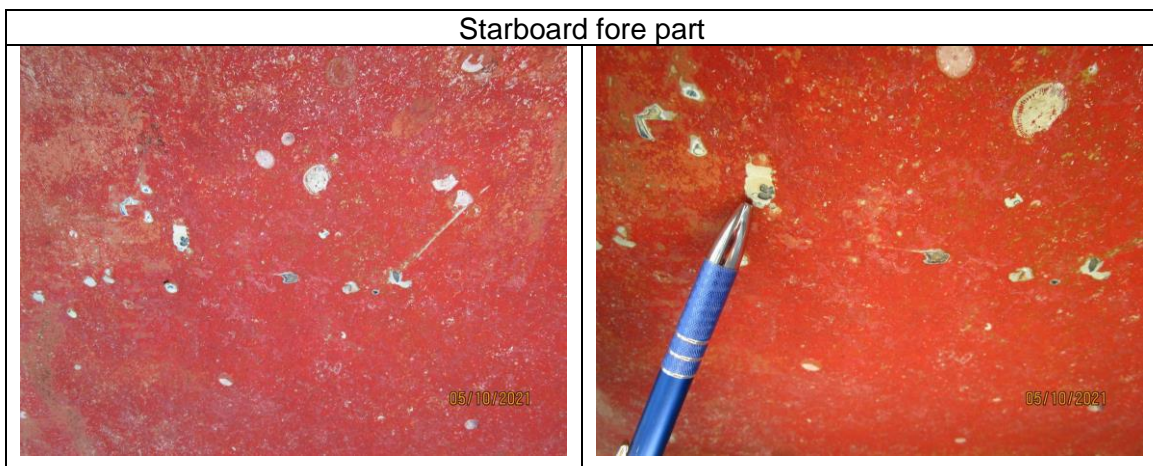
- Isolated small spots where the fibre was exposed due to the lack of topcoat. These spots might be caused during the cleaning of the barnacles.

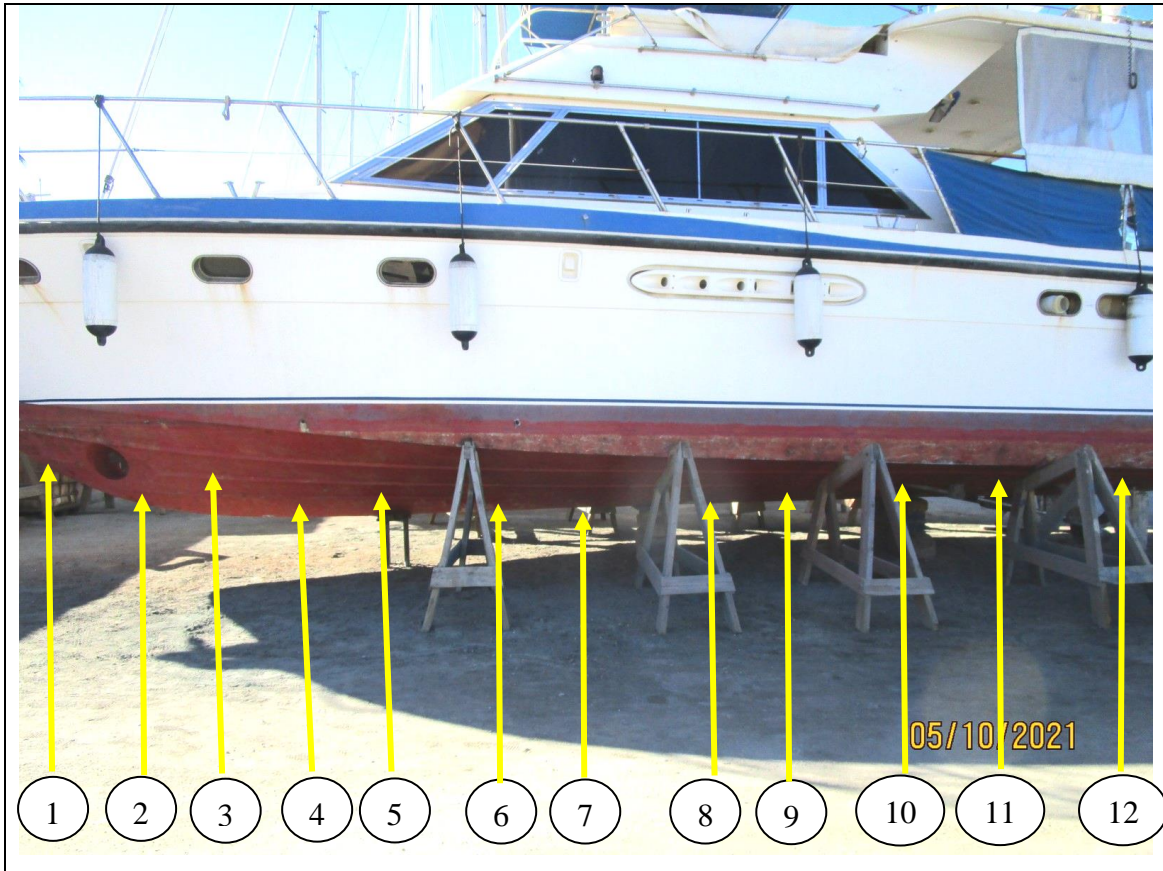
Readings were taken above the waterline as a baseline comparison and also below the waterline. The above waterline readings were low and to be expected. It was detected elevated level of humidity below waterline.

Moisture readings were taken in 12 areas (in both sides) as it is shown in the following picture:

Side \ Area	Port	Starboard
1	50	80
2	85	90
3	70	70
4	80	80
5	70	80
6	100	100
7	90	90
8	100	90
9	100	100
10	75	80
11	100	90
12	85	90

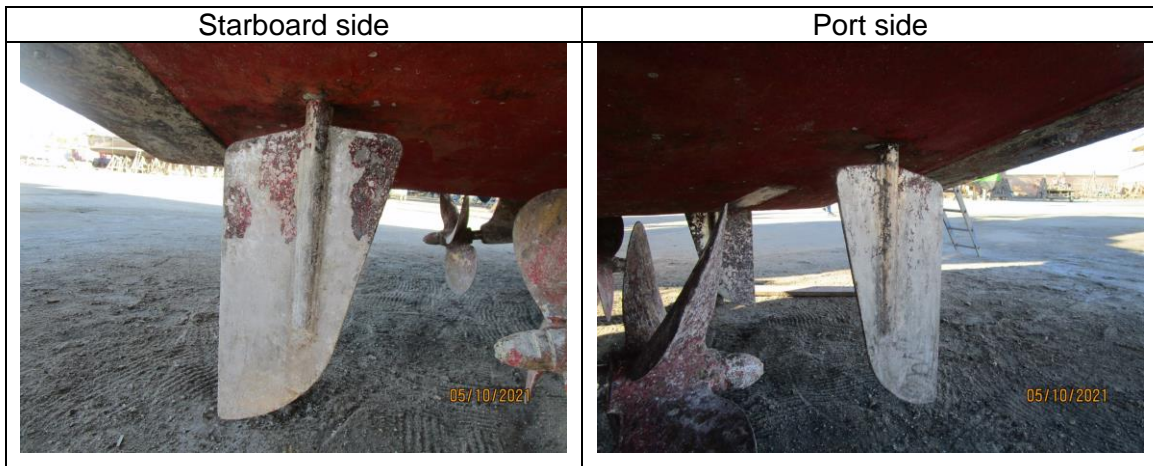
The rudder blades were inspected and noted to be constructed from a yellow metal believed to be bronze alloy or similar. Both were in sound condition with no evidence of contact damage or corrosion. Both rudder blades were secure with only minimal movement noted in the stock suggesting the bearings remain in a workable condition.

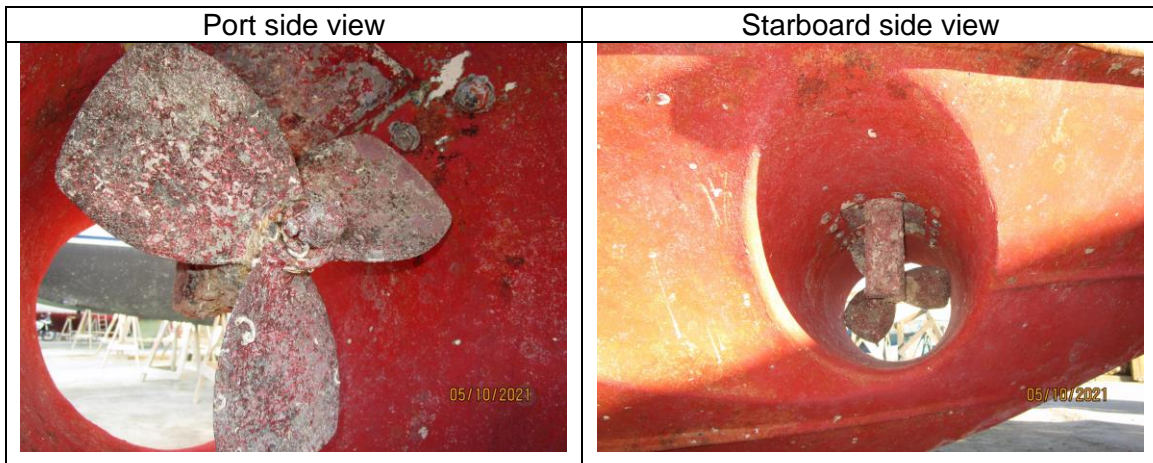
The bow thruster was inspected externally and found in sound condition with no evidence of damage to the bow thruster blades or the GRP tunnel. On the propeller still remains some barnacles.

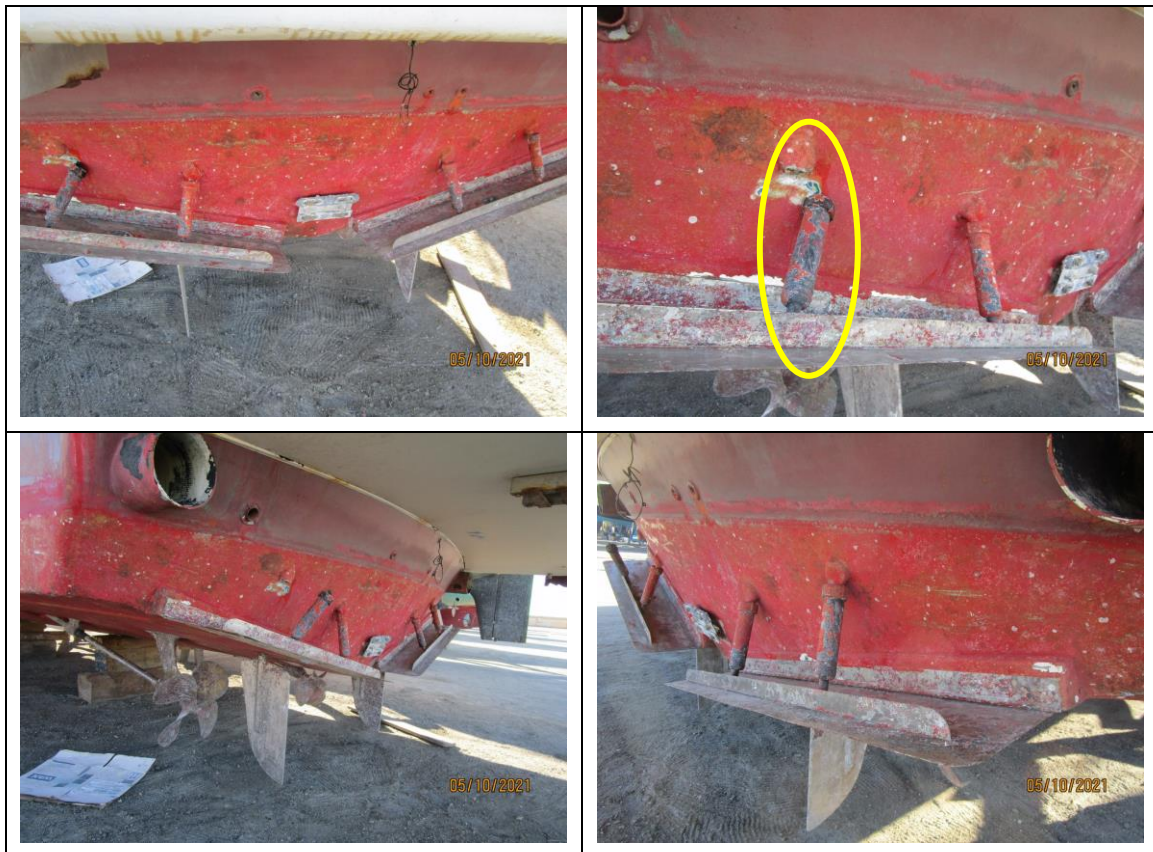
Intact and without evidence of elevated moisture levels.

The boat is fitted with two trim hydraulic tabs. The trim tabs were not tested. One of the hydraulic for the port side tab was detached.

Zincs appeared serviceable.

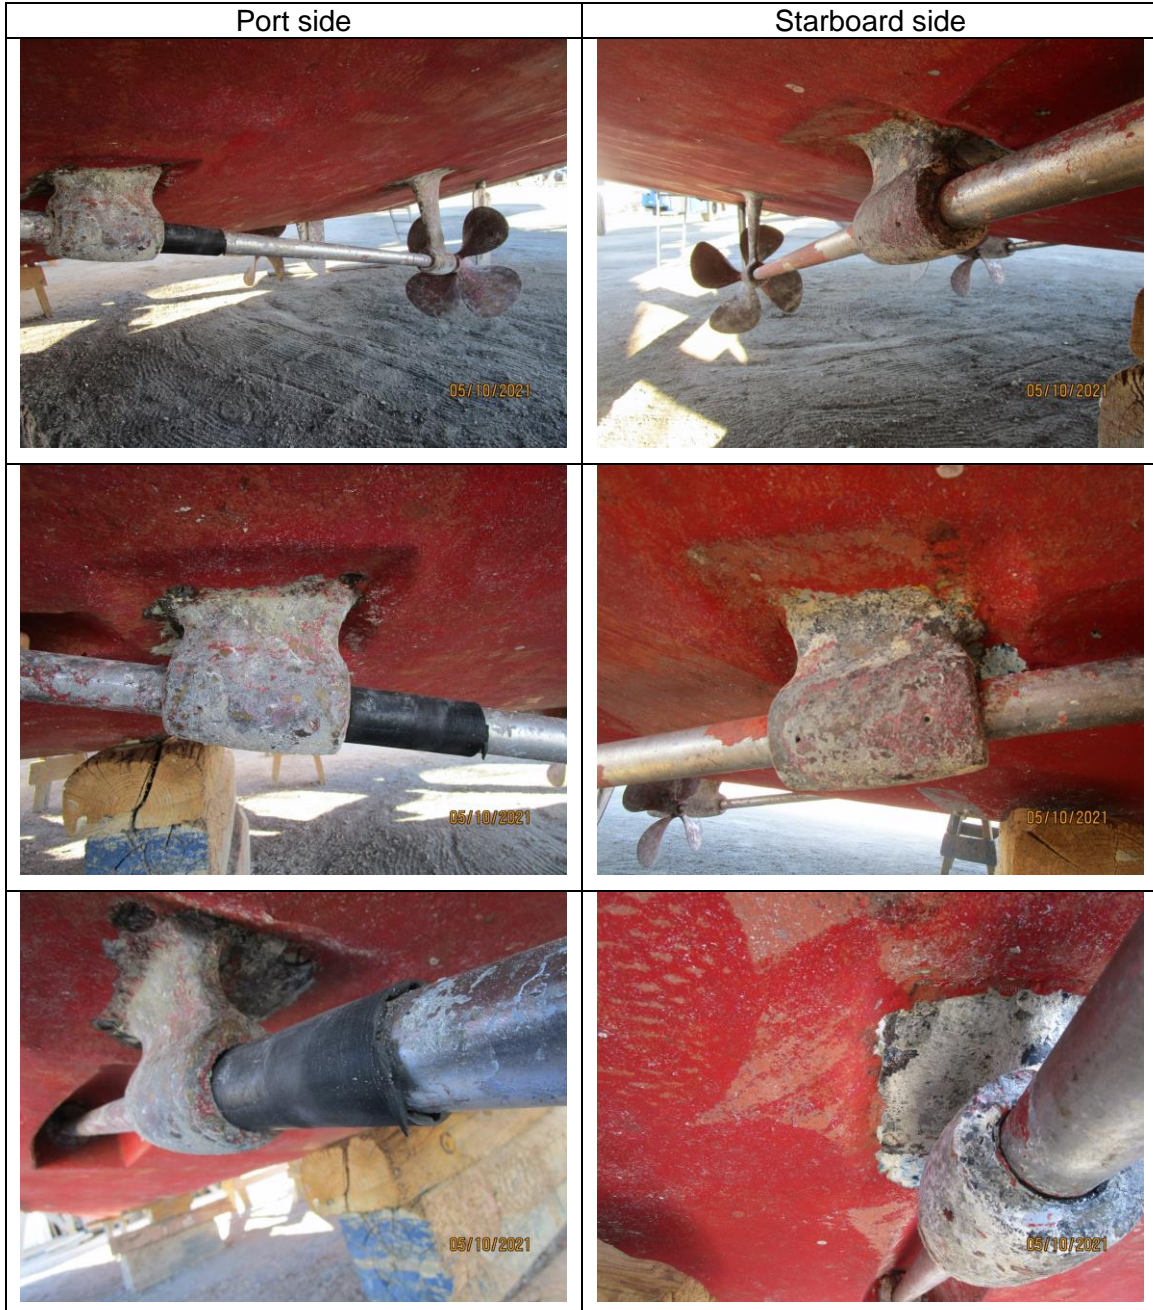
Both propeller shafts, P-brackets and propellers were inspected. All were noted sound with light surface scaling from marine fouling. All would benefit from polishing.

Two bronze alloy, four bladed propellers were found in sound condition based upon an external visual inspection. Both were rotated and found to be central relative to the stern seal and P-bracket. They were found secure to the shafts and all blade tips found in sound condition with no evidence of obvious contact damage or corrosion.

The shaft alignment was not assessed. Both P-brackets were of a yellow metal believed to be a bronze alloy. Both P-brackets were secure and the cutlass bearing

showed signs of wear. Port side cutlass bearing is out of place and should be replaced. P-brackets fitting plates showed some corrosion.

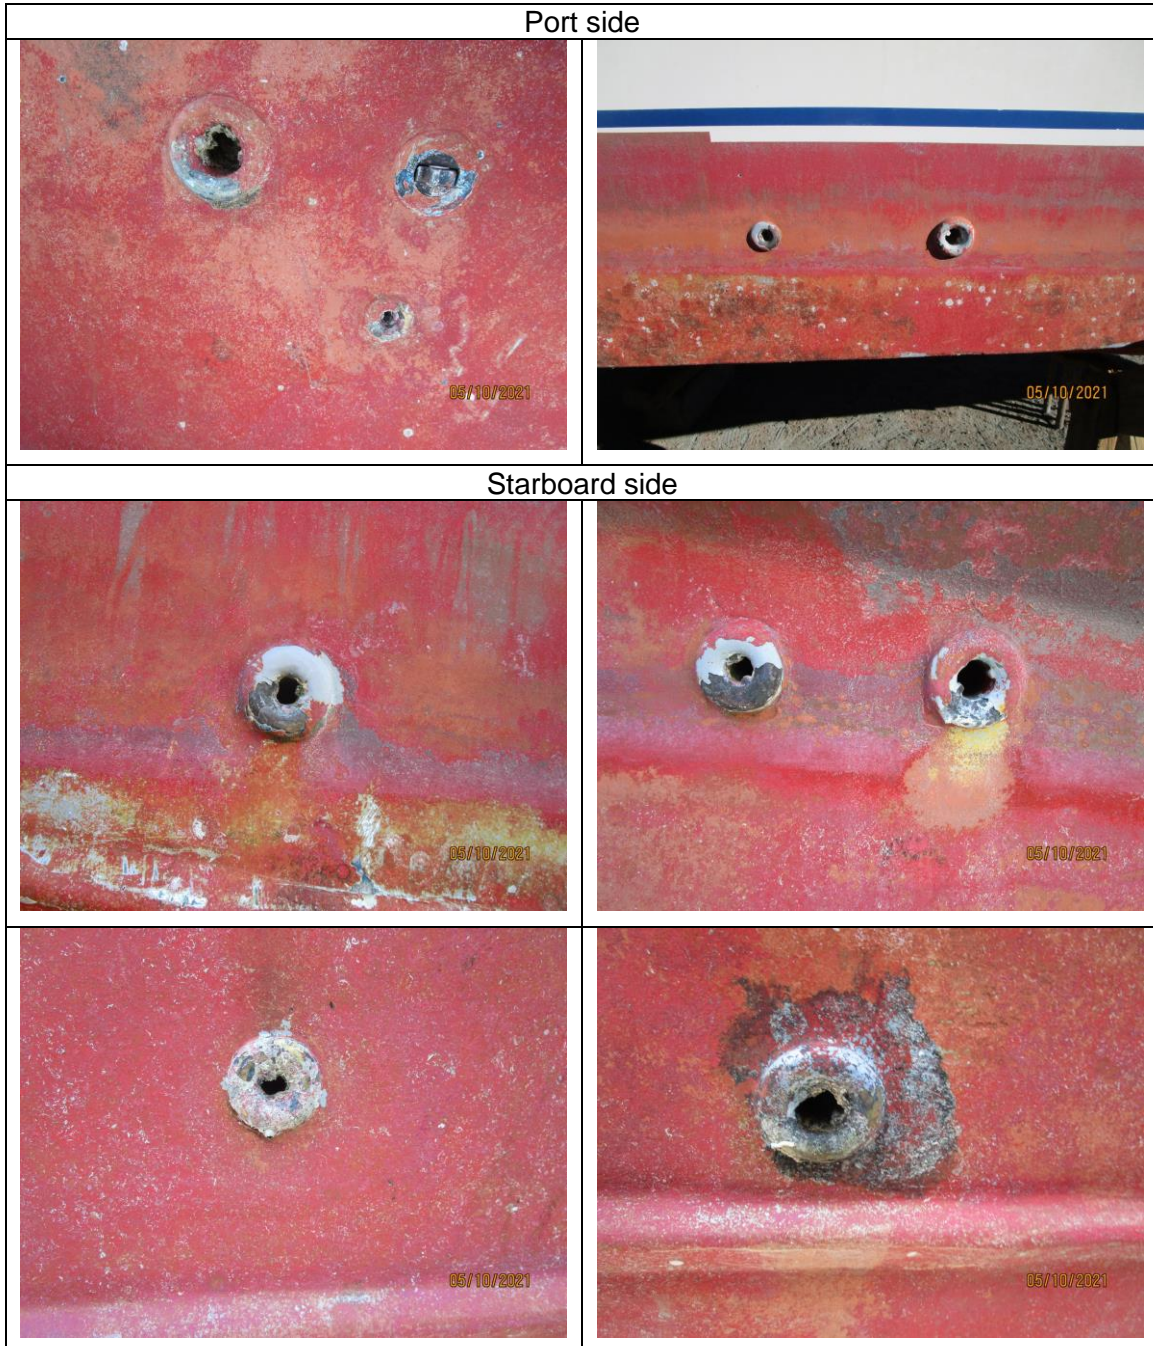
All thru hull fittings are adequately secured and sealed to hull.
