MY "FRANZISCA"

Hull Inspection Report

Reference: 2271021

MATTER: M.Y. "FRANZISKA" hull inspection below waterline

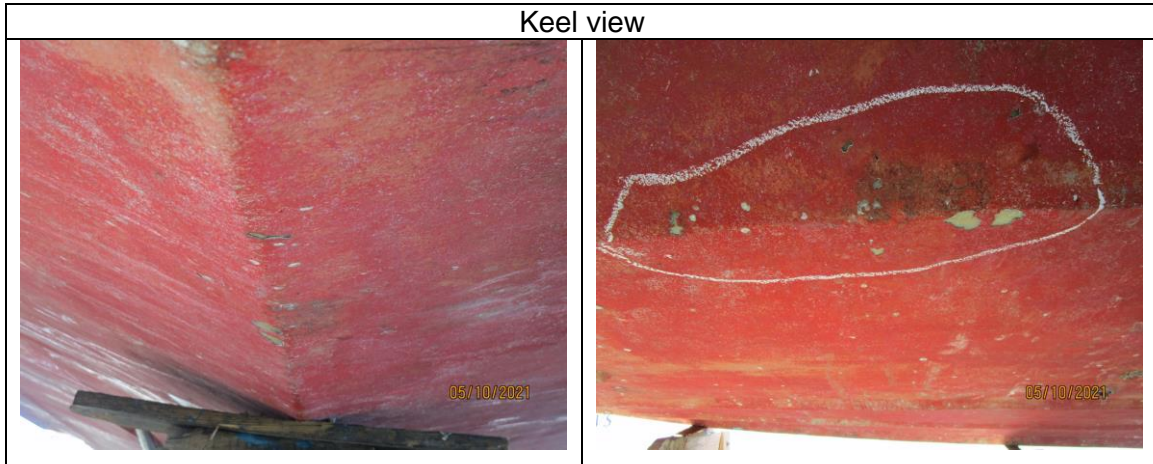
- There was an area in the keel at the centre of the boat where it was found some small spots which the topcoat was missing. Fibre and resin were exposed.

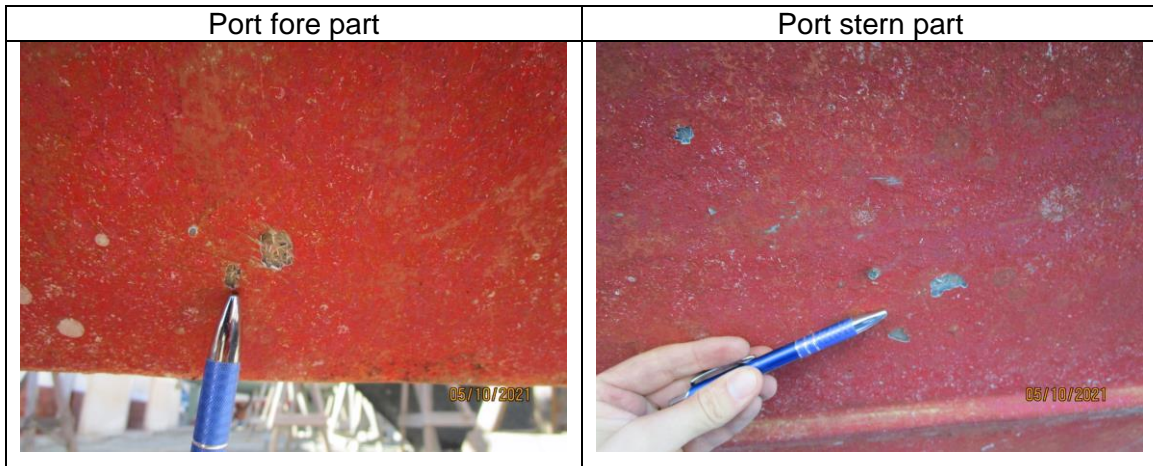
- Isolated small spots where the fibre was exposed due to the lack of topcoat. These spots might be caused during the cleaning of the barnacles.

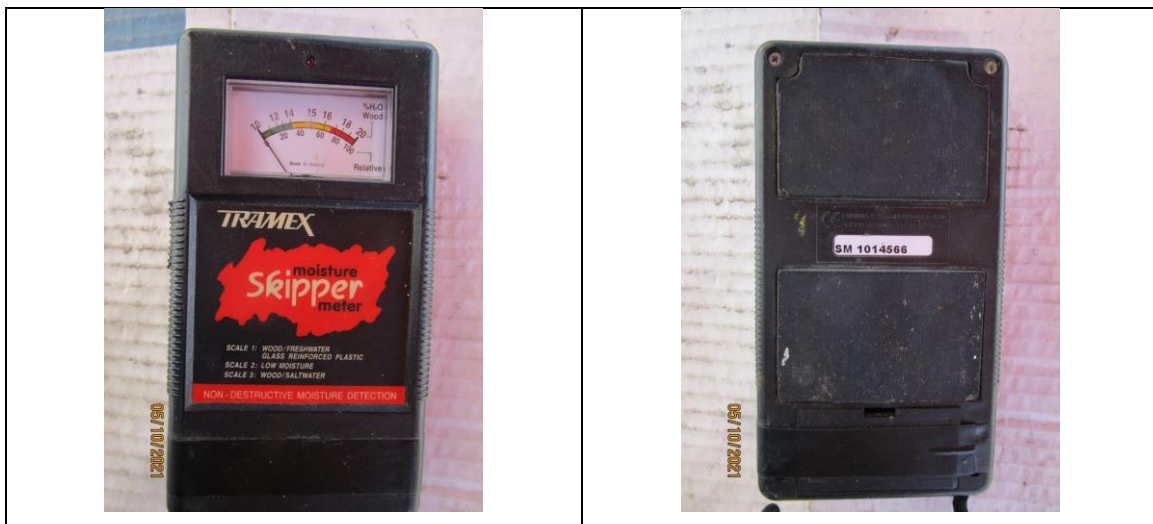
Readings were taken above the waterline as a baseline comparison and also below the waterline. The above waterline readings were low and to be expected. It was detected elevated level of humidity below waterline.

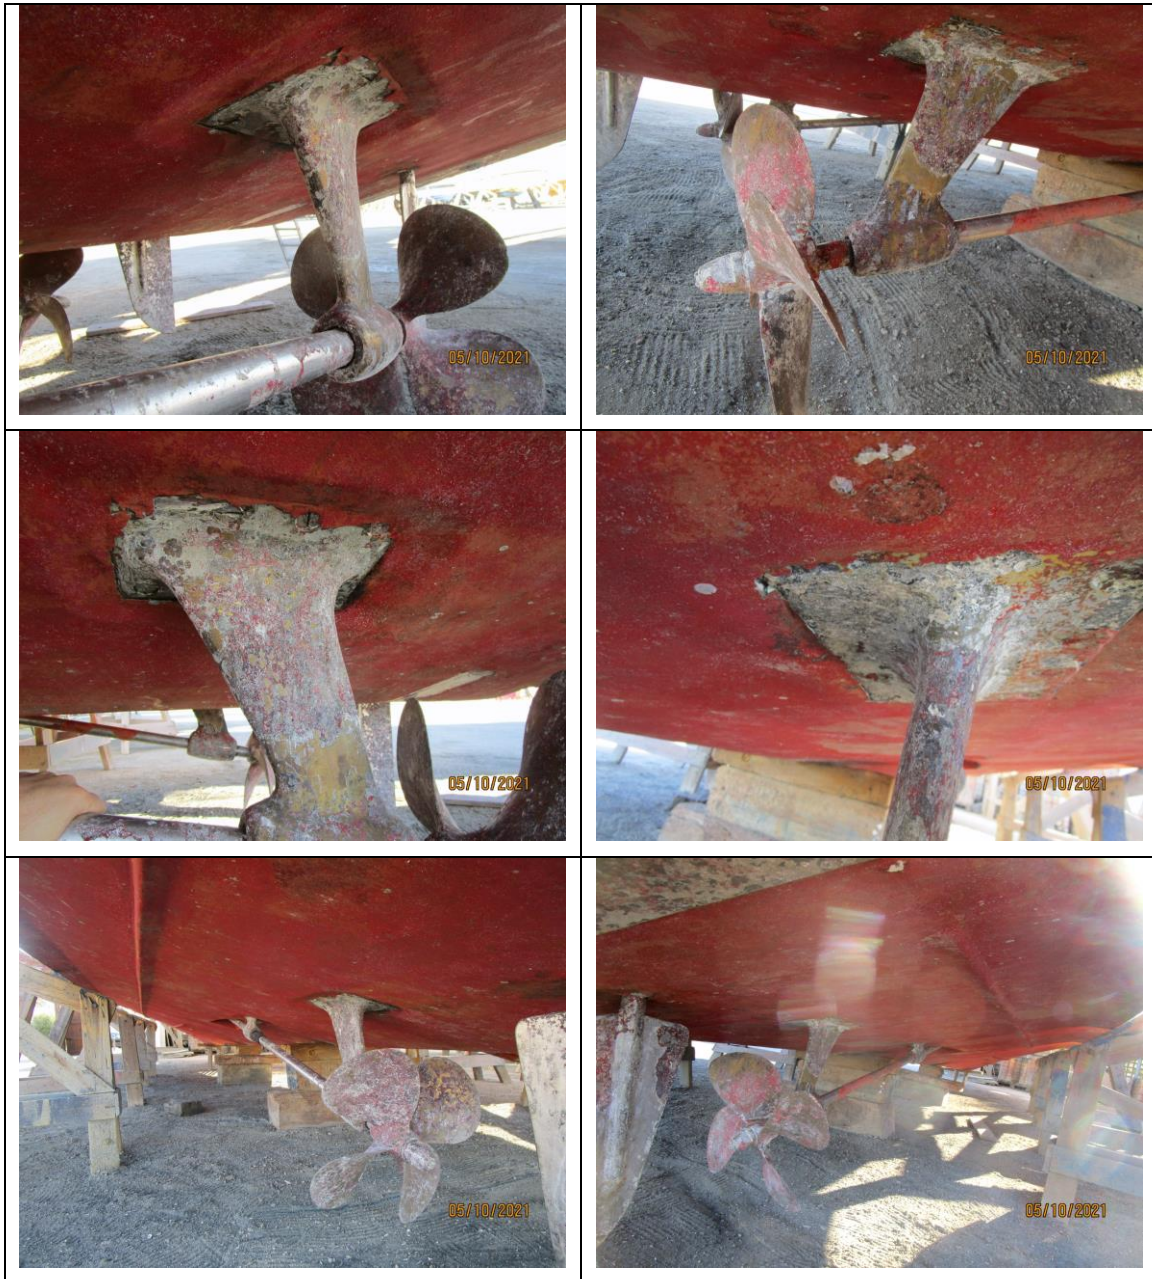
showed signs of wear. Port side cutlass bearing is out of place and should be replaced. P-brackets fitting plates showed some corrosion.
